BULETINUL INSTITUTULUI POLITEHNIC DIN IAȘI
Publicat de
Universitatea Tehnică „Gheorghe Asachi” din Iași
Volumul 69 (73), Numărul 2, 2023
Secția
CHIMIE și INGINERIE CHIMICĂ
DOI: 10.5281/zenodo.8163005

ON THE ECOLOGICAL STATE OF MOLDOVA RIVER IN THE CORDUN AREA

PETRU-DANIEL BRĂNIANU, MIHAIL LUCA* and VALENTIN BOBOC

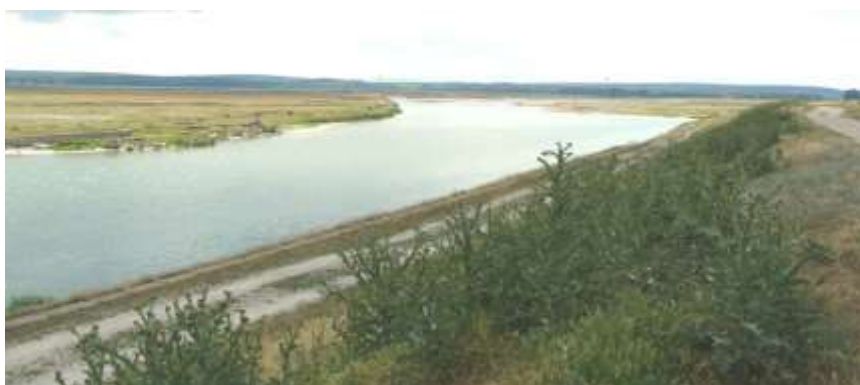
- the main riverbed has a path in the form of a large arc of curved circle to ensure the supply of water capture located on the river bank (Fig. 4 and Fig. 5);

Fig. 4 – View of the river Moldova River before branching into the area in the Cordun area.

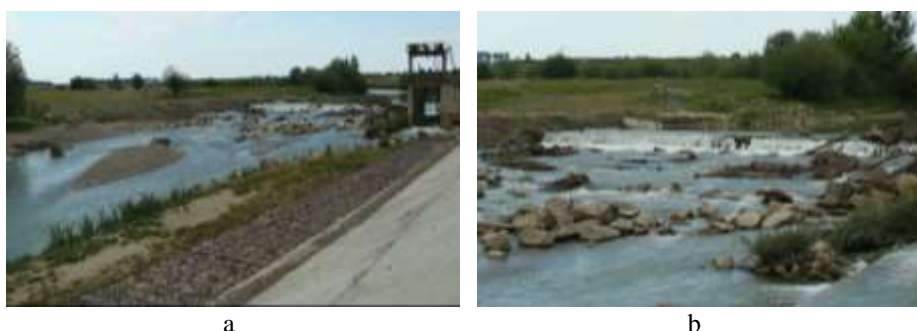
- the left arm of the Moldova river (the main bed) was in an advanced state of degradation, a situation that affects water capture (Fig. 5); as a result, the bed has been recently rehabilitated through the following works: a - reinforced concrete bottom threshold; reinforced concrete energy dissipating pool, and stone and boulder energy dissipator;

Fig. 5 – The current state of the catchment area: a - general view; b - detail regarding the energy dissipation basin at the bottom threshold.

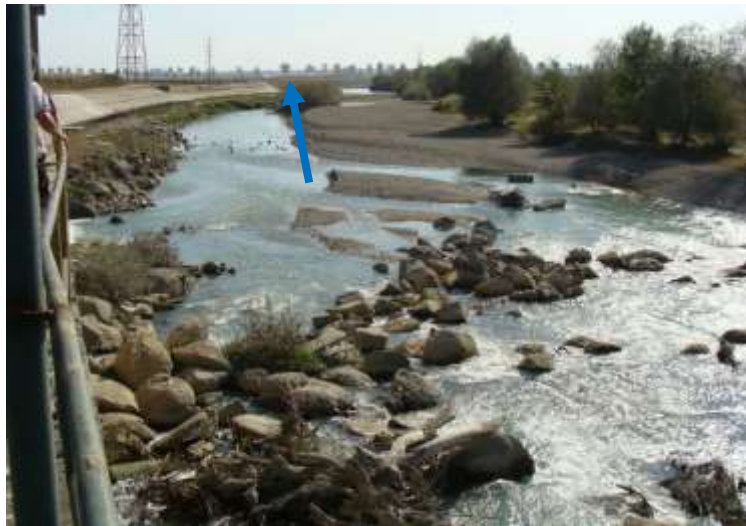
- the left slope of the main riverbed downstream of the catchment has been rehabilitated with a protection from concrete slabs at the top and stone gabions at the bottom on a length of about 120 m (Fig. 5 and Fig. 6); further on, the slope is protected by gabions filled with river stone;
- the slope on the right bank of the main bed has been rehabilitated downstream of the catchment with a protection of river stone gabions;
- the hydraulic characteristics of the water flow in the main stream (high flows and flows, $v = 1.30 - 2.60$ m/s) do not determine the viable conditions of protection of the aquatic habitat on the section of the catchment area (Fig. 6).

Fig. 6 – The morphological characteristics of the bed on the left arm of the Moldova River in the location of the catchment and downstream of it.

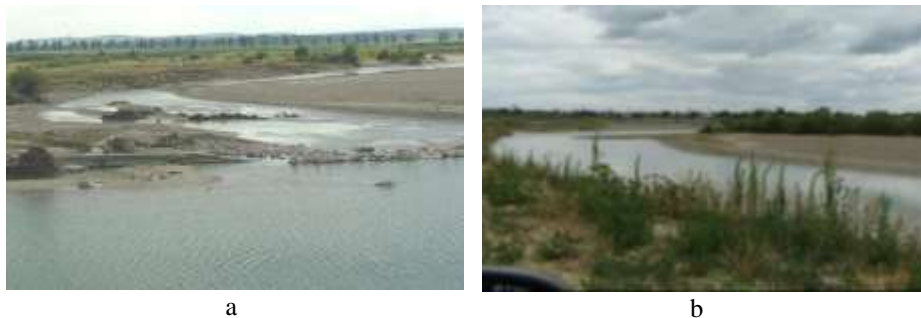
Fig. 7 – Current status of the secondary riverbed: a - the input sector; b - the central sector.

- the secondary riverbed presents at the entrance a linear sector, then a sector in the form of a circle arc, and the output sector is slightly curved (Fig. 3, Fig. 7 and Fig. 8);

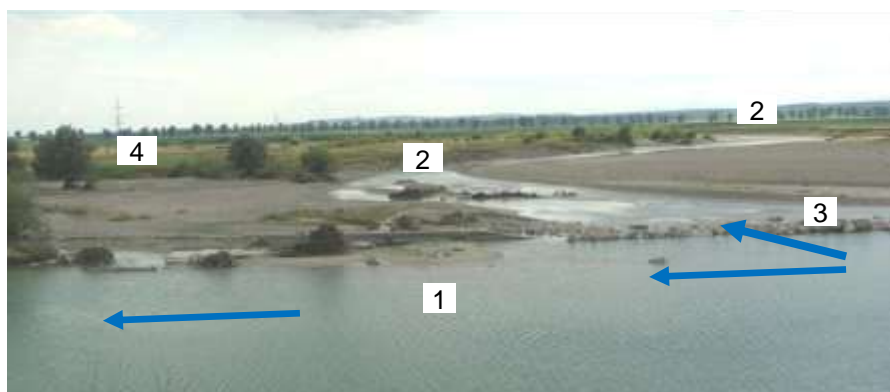
- a concrete spill is made in the entrance section of the secondary riverbed (Fig. 8); the spill is degraded, the operating state is ensured by adding concrete elements and stone blocks after each flood;

Fig. 8 – The branching of the Moldova River bed upstream of the catchment: 1 - the main riverbed; 2 - secondary riverbed; 3 - prague spill; 4 - island.

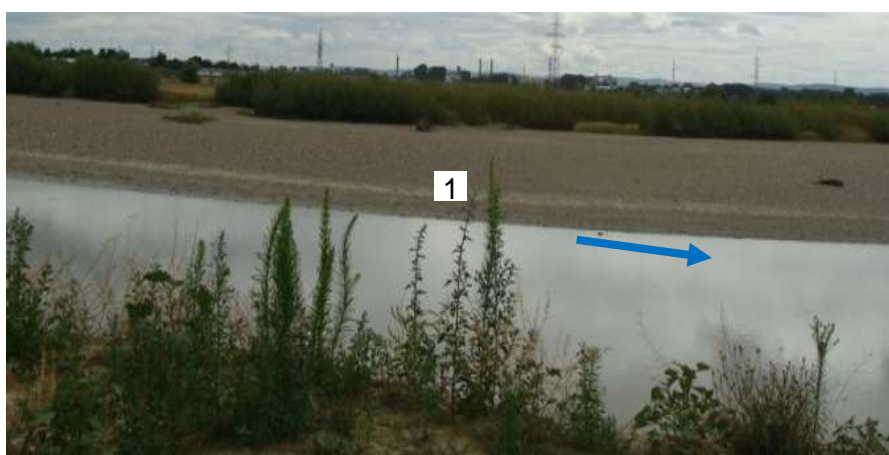
Fig. 9 – The state of operation at medium flows of the secondary bed in the central sector (1 - island).

- field research has shown that the aquatic habitat in the secondary riverbed is strongly disturbed by the absence of the riverbed development works and the permanent impact of the maximum flow.

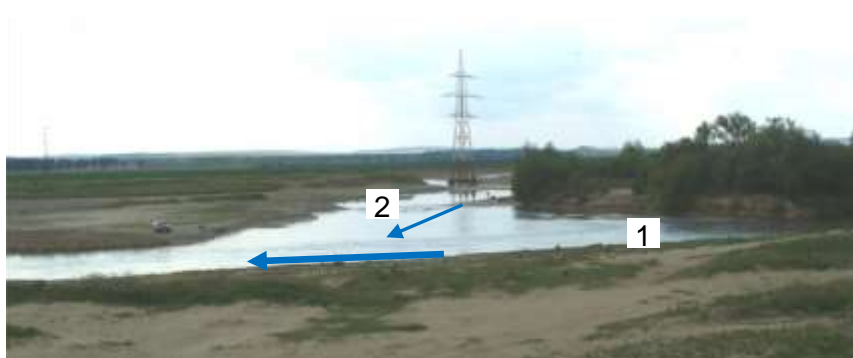
Fig. 10 – Current status of the secondary riverbed in the output sector;
1 - main riverbed; 2 - secondary riverbed.
