BULETINUL INSTITUTULUI POLITEHNIC DIN IAȘI
Publicat de
Universitatea Tehnică „Gheorghe Asachi” din Iași
Volumul 69 (73), Numărul 2, 2023
Secția
CHIMIE și INGINERIE CHIMICĂ
DOI: 10.5281/zenodo.8163005

ON THE ECOLOGICAL STATE OF MOLDOVA RIVER IN THE CORDUN AREA

PETRU-DANIEL BRĂNIANU, MIHAIL LUCA* and VALENTIN BOBOC

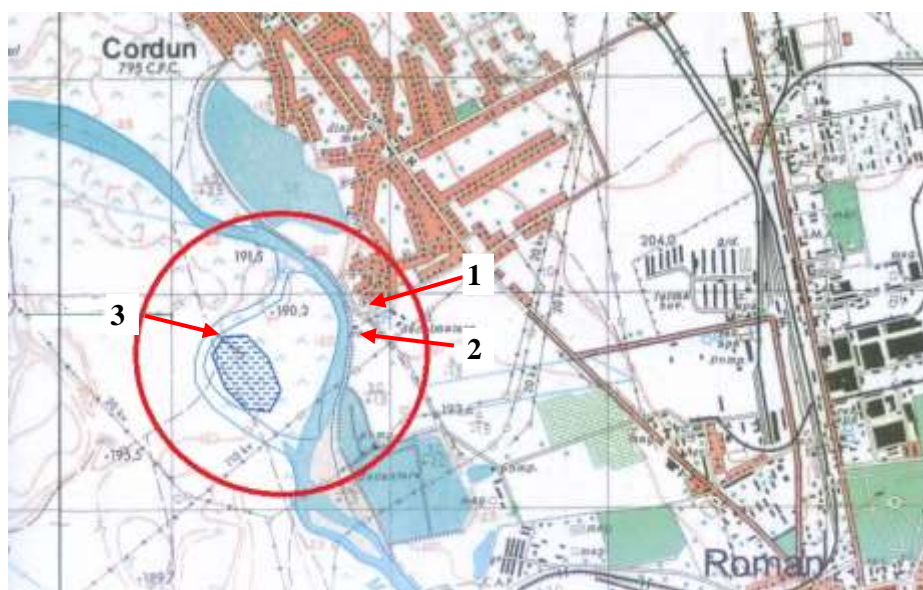
Fig. 2 – The location of the study area in the catchment area on the Moldova River in the Cordun area, Neamț County; 1 – water capture; 2 – main riverbed; 3 – secondary riverbed.

The paper presents the analysis of the ecological status of the river Moldova in the area of Cordun locality in Neamț County. The studies and researches were carried out on the river Moldova, on the sector of the location of water capture for the industrial area of the Roman city. The water catchment influenced the morphology of the minor riverbed of the Moldova River on a length of about 400 m (Luca, 2011). The construction of the capture construction required the division of the river into two arms by creating an island in the area of Cordun (Fig. 2).

The island in the Cordun area is located at approx. 6.00 km upstream of the confluence of the river Moldova with the Siret River. The surface of the island is 21.0 ha. The industrial water catchment is located on the left arm of the river.

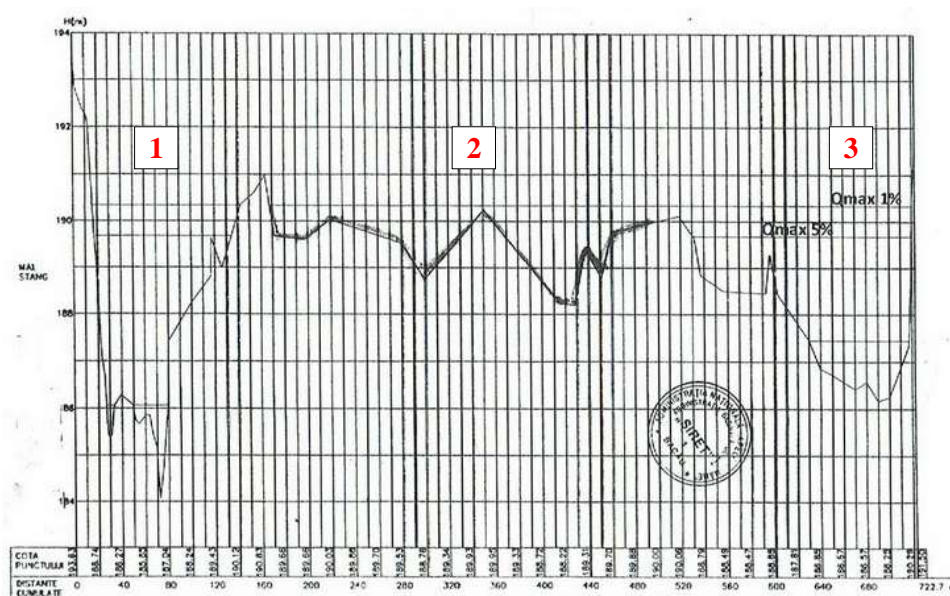
Fig. 3 – Transversal profile in the research area downstream of the catchment:
1 – left arm; 2 – island; 3 – right arm (Luca, 2011; A.B.A. Siret, 2010).

made downstream of the water catchment highlighted the differentiated geometric shape of the two arms of the Moldova river bed (Fig. 3).

The left arm of the river Moldova in the catchment area has a calibrated section and is rectilinear on a length of 320 m. On this length there are a series of hydrotechnical constructions for regulating the flow of water: bottom threshold, dissipation basin, shore defence. Water flow on the left arm occurs at high speeds (about 1.29 - 2.60 m/s), a situation that does not meet the conditions of protection of the aquatic habitat.

The right arm of the river is fed only at high flows, and the entrance area is provisionally arranged in the form of a spillway. Research has shown that the aquatic environment on the right arm is degraded at the current stage. The morphology of the right arm is continually modified by floods, but also by the average flow rates that occasionally enter due to the degradation of the entrance threshold. The morphological changes are represented by erosion zones and alluvial deposit areas along the right arm length. The water stagnates on some sectors of the right arm and creates an anaerobic environment, which influences the development of the aquatic environment.
